Combined SEM and Raman spectroscopy A new analytical tool for corrosion and oxidation studies - analysis of oxidised copper wire and reactor steel

SEM-Raman investigation into oxidation of copper wire

SEM-Raman investigation into oxidation of reactor steel

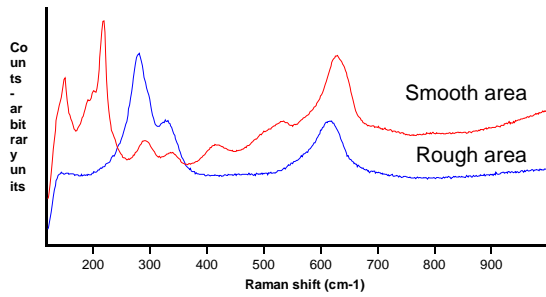
Figure 4
Raman spectra from smooth and rough areas

The spectrum from the smooth area has Raman bands consistent with **cuprous oxide** (Cu_2O) or **cuprite**.

The blue spectrum is similar to that of **cupric oxide** (CuO) or **tenorite** but the peaks are rather broad implying that the degree of crystallinity is low - this is consistent with the SEM observations that show a highly disordered surface. There is no evidence for the presence of hydrated copper oxides (e.g. malachite, atacamite) due to the absence of O-H bands in the spectra.

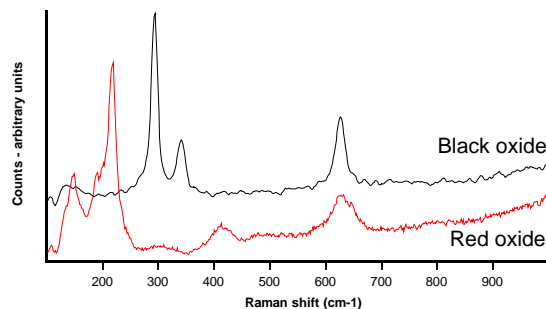
Figure 7
Raman spectra from black and red oxides

The spectrum from the red oxide is characteristic of **cupric oxide** (CuO) - the black matches **cuprous oxide** (Cu_2O).

The wire heated at 750°C has appears to have grown a Cu_2O layer and then a thick CuO layer much of which has subsequently spalled away. The wire heated at 900°C has an adherent CuO film, which implies it is quite thin.

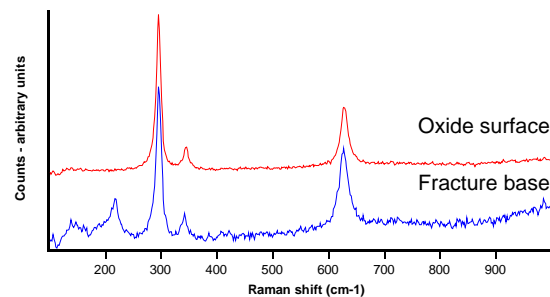
Figure 10 shows spectra taken from the base of the fracture area as shown in Figure 9 (in blue), and from the oxide surface (in red).

Both spectra are characteristic of **cupric oxide** (CuO), although the spectrum from the fracture base has additional bands (at 148 cm^{-1} and 216 cm^{-1}) from **cuprous oxide** (Cu_2O).

Figure 10
Raman spectra from the oxide surface and fracture base

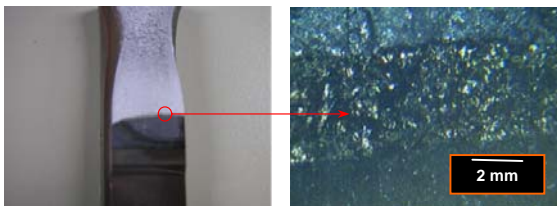
A steel component (Figure 11) from a high-pressure, high-temperature, high-stress region of the reactor started to show signs of cracking - this was believed to be as a result of oxidation. The part was taken out of service and provided for analysis to identify the oxides present, to understand the oxidation process, and assess its implications.

Figure 11
The image left shows the part that had been withdrawn from service and the interface between the unaffected and oxidised regions. The low power optical micrograph on the right shows a higher magnification image of the interface

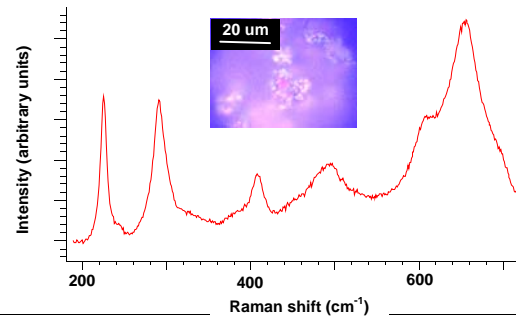
Examination of the oxidised region using a conventional Raman microscope yielded valuable data (see Figure 12). It was difficult to relate the optical microscope images to the macrostructure because of the highly topographic nature of the oxide surface, and the limited depth of field of the high-power objective - this is illustrated by the inset optical micrograph.

Figure 12
Raman spectrum collected from within the oxidised region, the inset optical micrograph shows the point from which the spectrum was collected

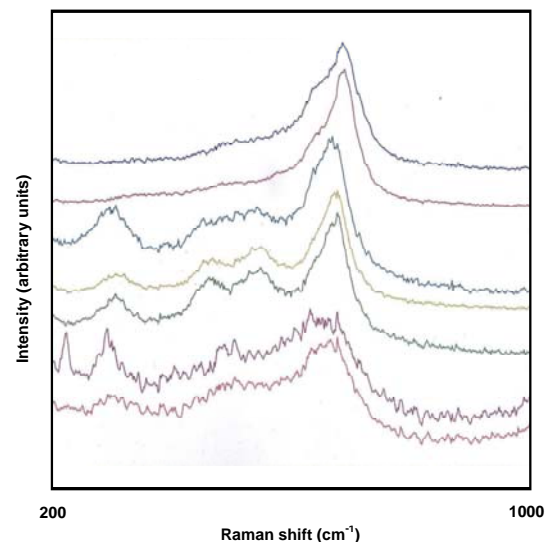
Using the SEM-SCA, spectra and SEM images were taken at the top of the crack (the topmost spectrum in Figure 15). Further spectra were collected at 1 mm intervals through the oxidised region down to the oxide/metal boundary (the bottom spectrum in Figure 15).

Figure 15
Raman spectra from different depths in the oxide layer

The spectra show there is a gradual transition from **magnetite** (Fe_3O_4) to **haematite** (Fe_2O_3) – this is typical of a gradual oxidation process where a thin film of haematite forms initially, but is soon overgrown with magnetite.

It would appear that the oxide grew gradually until it reached a thickness where it could no longer tolerate the stresses imposed on it, and cracked. Cracking of course exposes a fresh metal surface, which can then oxidise; if this process is allowed to continue then, after multiple oxide growth and cracking cycles, the cross-section of the part would be so reduced that its strength could be critically compromised.

The kinetics of oxide growth on steels, however, are well characterised, and this study has confirmed that the oxidation process is conventional. A maintenance regime that involves replacing the part before oxidation compromises its performance can now be planned with confidence.
