SAFETY	2
VERSION HISTORY SUMMARY	3
SOFTWARE RELEASE (UCCSUITE 4.4).....	4
GENERAL NOTES	4
<i>New Functionality</i>	4
<i>Bug Fixes</i>	5
INSTALLATION MANAGER	6
<i>New Functionality</i>	6
UCCSERVER 4.30.11	6
<i>Changes - 4.30.06 to 4.30.07</i>	6
<i>Changes 4.30.07 to 4.30.08</i>	6
<i>Changes 4.30.08 to 4.30.09</i>	7
<i>Changes 4.30.09 to 4.30.10</i>	7
<i>Changes 4.30.10 to 4.30.11</i>	8
UCCASSIST-2 VERSION 2.0.0.56	9
<i>New Functionality</i>	9
<i>Bug Fixes</i>	9
SERVICE PACK 6 (UCCSUITE 4.3.6).....	10
NEW FUNCTIONALITY	10
BUG FIXES	10
SERVICE PACK 5 (UCCSUITE 4.3.5).....	10
NEW FUNCTIONALITY	10
BUG FIXES	10
SERVICE PACK 4 (UCCSUITE 4.3.4).....	10
NEW FUNCTIONALITY	10
BUG FIXES	10
SERVICE PACK 3 (UCCSUITE 4.3.3).....	11
NEW FUNCTIONALITY	11
BUG FIXES	11
SERVICE PACK 2 (UCCSUITE 4.3.2).....	11
NEW FUNCTIONALITY	11
BUG FIXES	11
SOFTWARE RELEASE (UCCSUITE 4.3).....	12
GENERAL NOTES	12
<i>New Functionality</i>	12
<i>Bug Fixes</i>	12

Version history summary

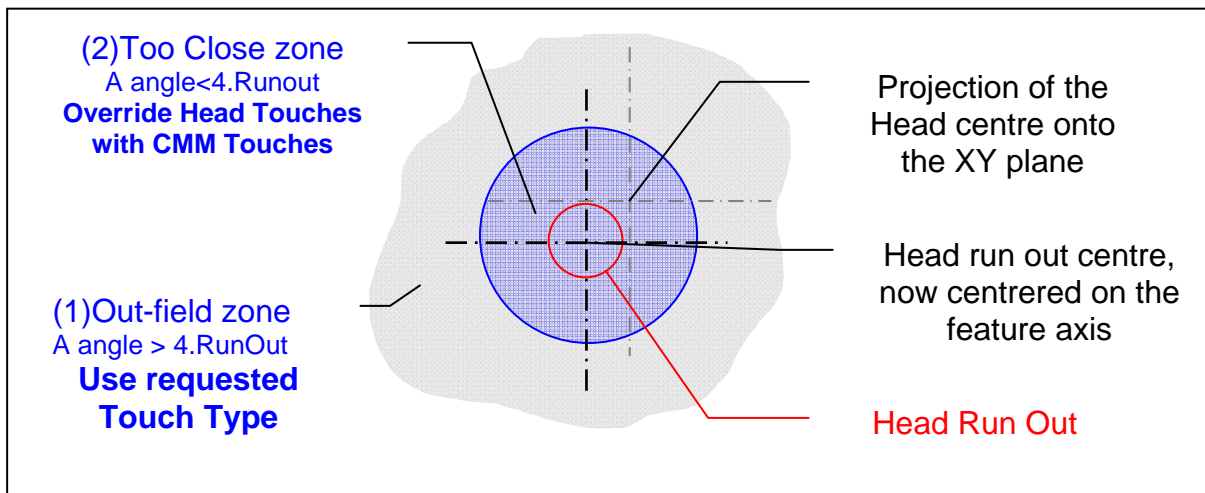
Diagram of Zone to determine PtMeas Touch type override conditions

The zone is determined by a combination of the RunOut of the head. (Runout is calculated internally from the Head calibration data) and a multiplier parameter (see below) The test of zone is calculated based on the PtMeas Approach point. The parameters to control the multiplier for the zone are found in the UCCserver.ini File and are :-

NOTE – These parameters should both be set to the same value – the default is 4. By setting the values to 0, this function is turned off.
